## Focused Soil Vapor Investigation

**FOCUSED SOIL VAPOR INVESTIGATION  
REPORT AND LOW-THREAT CLOSURE REQUEST  
16800 Magnolia Street, and  
9025-9063 Recreation Circle  
Fountain Valley, California**

**November 4, 2024**

**Project No. 2047.28.09**

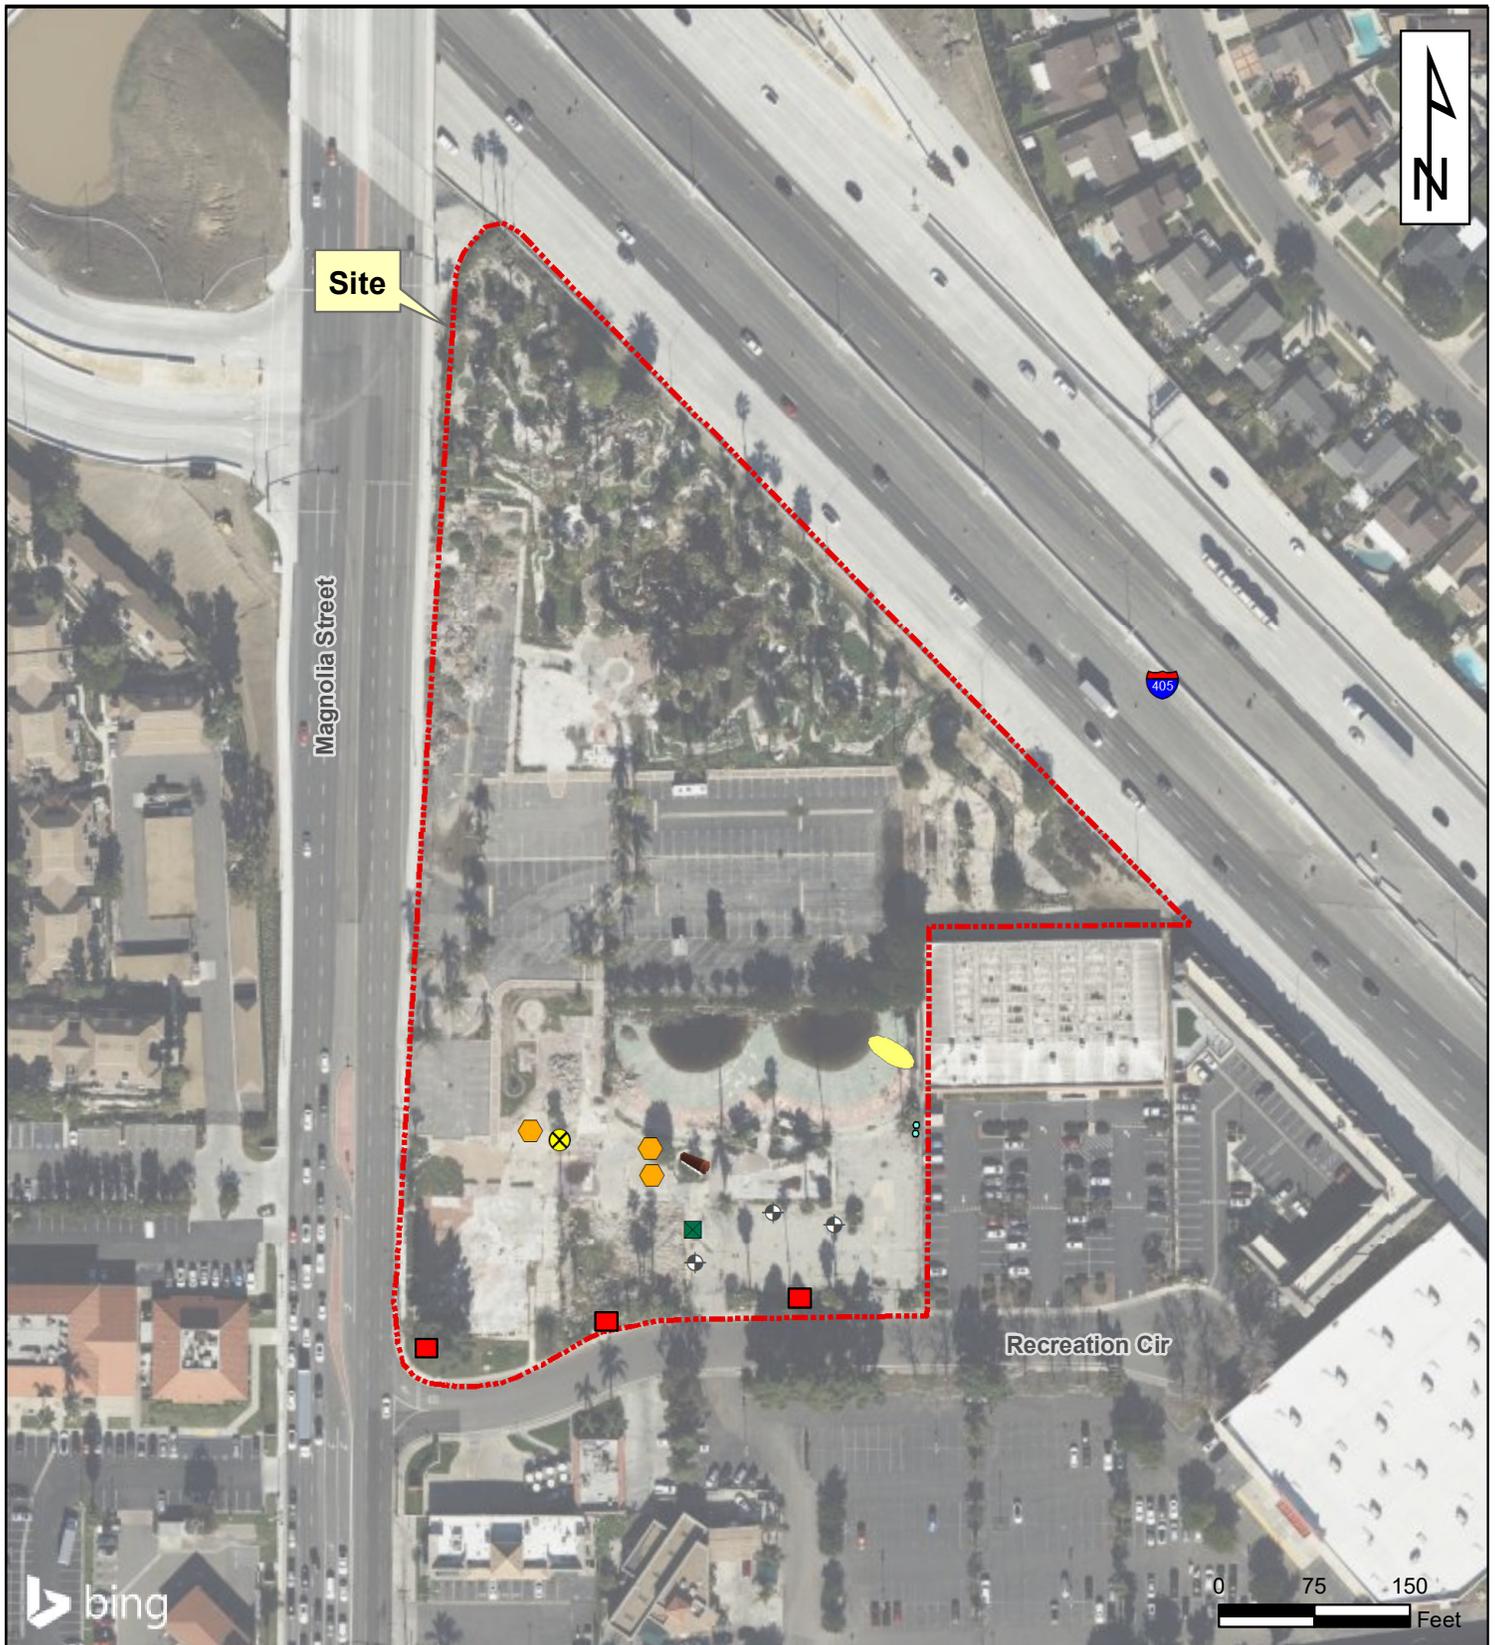
- Concrete Staining
- Leaked motor oil
- Two 55-gallon steel drums with soil
- Pad-mounted Transformer
- 1,000-gallon, steel, gasoline
- Site Boundary
- X Pool chemical and equipment room
- Former UST location
- + Observed abandoned groundwater wells

The Site consists of approximately seven acres of land covering five parcels identified as Assessor's Parcel Numbers (APNs) 143-294-01, 143-294-02, 143-301-31, 143-301-32, and 143-301-37 in Orange County. The Site was previously developed and operated as an amusement park until June 2020. It is currently a vacant, dirt lot, partially asphalt-paved, used by an automobile dealership for temporary vehicle storage. A Site Vicinity Map is shown on Figure 1 and a Site Plan is shown on Figure 2.

The Site is currently a vacant lot and is located in a mixed residential and retail-commercial area of Fountain Valley. The Site formerly operated as an amusement park until approximately 2020. The Site is generally bordered on the west and south by arterial streets followed by residential and commercial development. The Site is bordered along its entire eastern side by the San Diego Freeway (Interstate 405) with residential development located beyond the freeway to the east. A Site Vicinity Map is shown on Figure 1 and a Site Plan is shown on Figure 2.

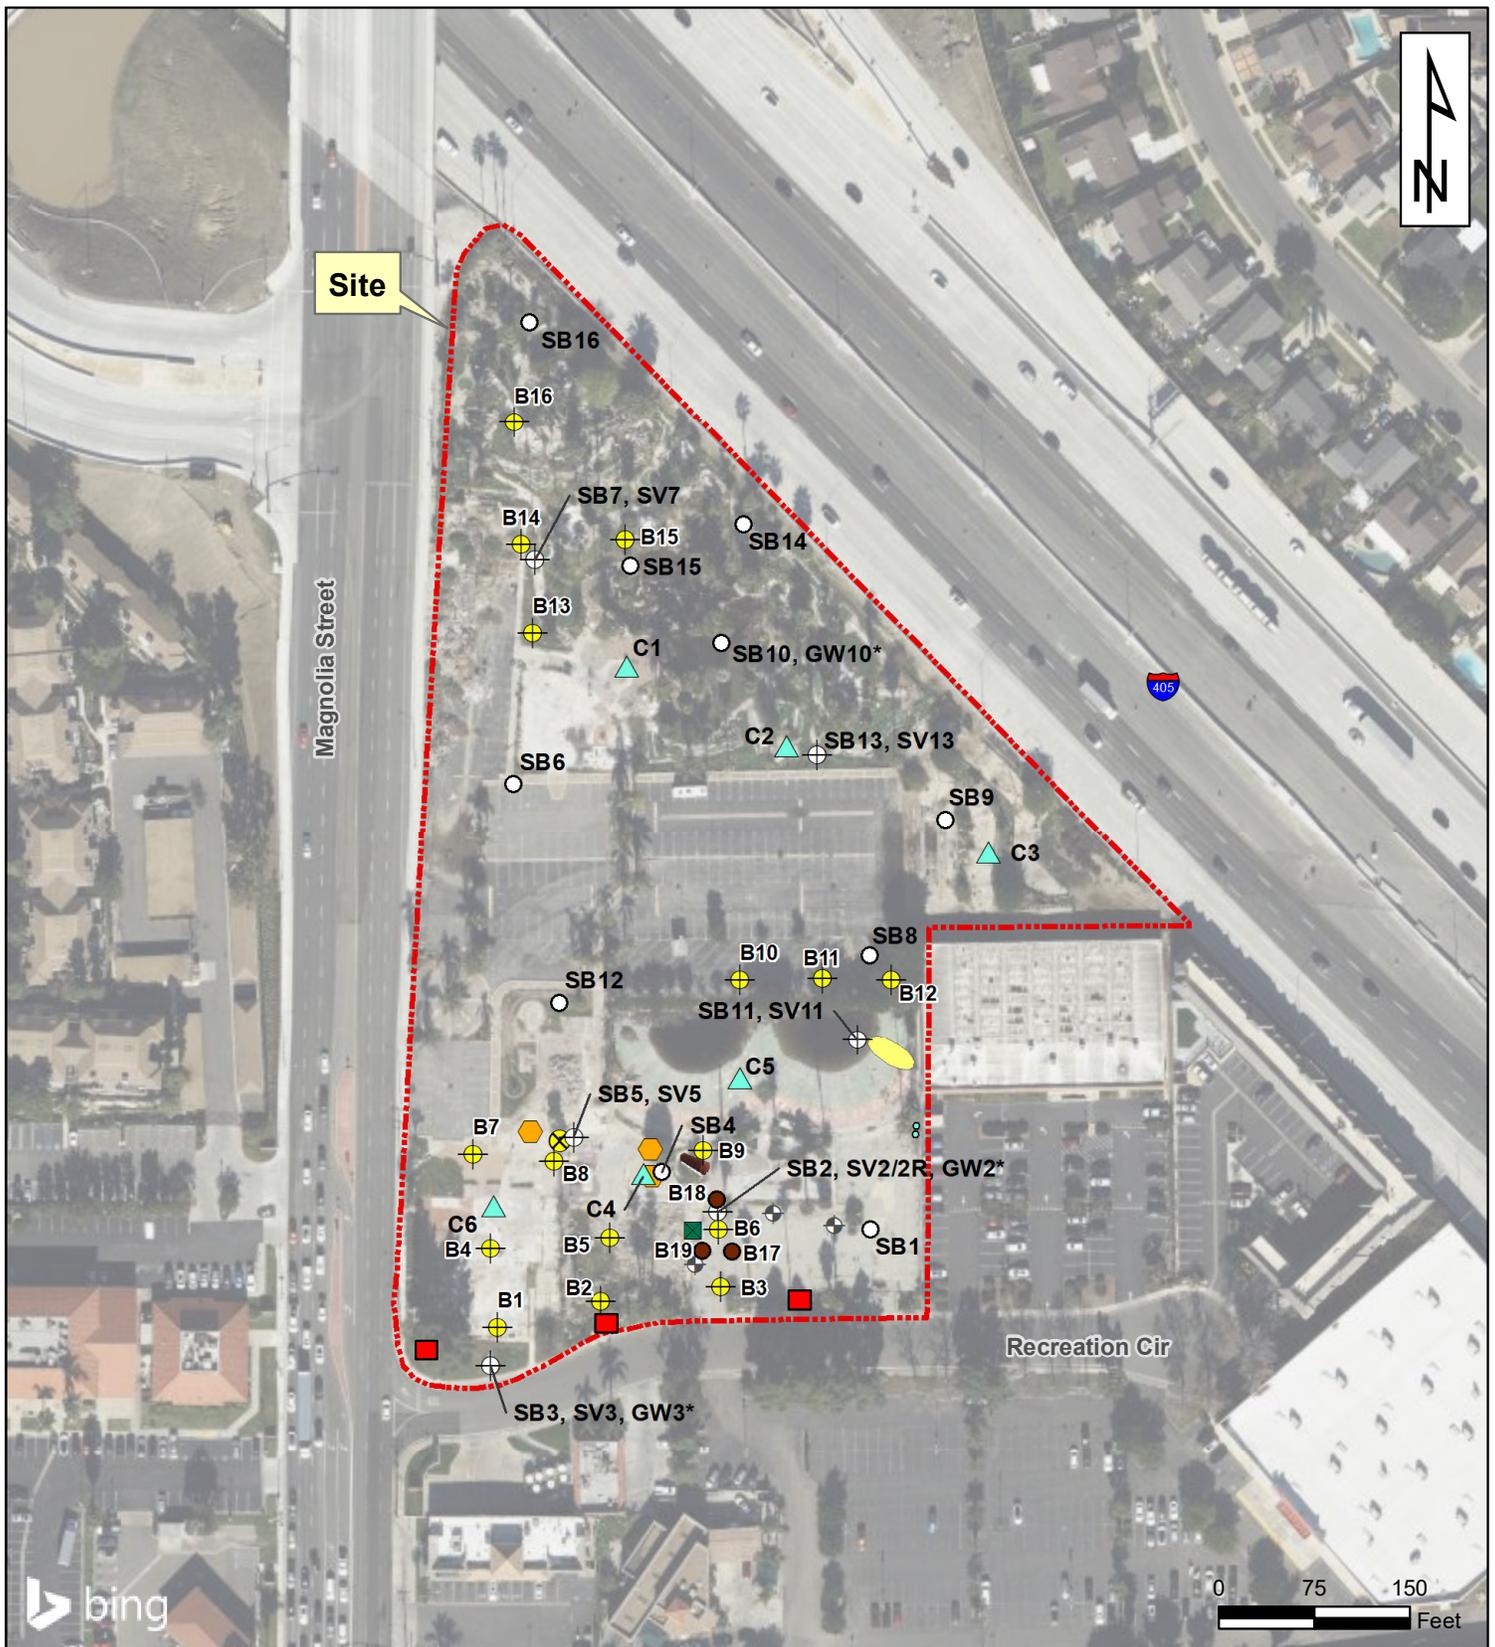
- Soil Boring 2021
- ⊕ Soil Boring and SVP 2021
- \* Grab Groundwater sample
- ▲ Concrete Sample
- ⬡ Concrete Staining
- ⊙ Two 55-gallon steel drums with soil
- 1,000-gallon, steel, gasoline
- ⊗ Pool chemical and equipment room
- ▭ Former UST location
- ⊕ Observed abandoned groundwater wells
- ⬡ Leaked motor oil
- ▭ Pad-mounted Transformer
- ⬡ Site Boundary
- Soil Boring 2024
- ⊗ Soil Boring and SVP 2024

In accordance with the OCHCA approved workplan, Northgate installed one new boring (SVP SV2R) on September 27, 2024 adjacent to the former UST and collected two soil vapor samples (one for Environmental Protection Agency [EPA] TO-15 analysis and one for EPA TO-17 analysis) from SV2R on October 2, 2024. The location of SVP SV2R is presented on Figure 3.

SVP SV2R was installed at a depth of approximately 5 feet bgs (Figure 3). The probe consists of a 1/2" x 1" Stone PolyPro vapor probe implant with 1/4-inch Speed Fit installed at 5 feet bgs. Teflon tubing (1/4-inch diameter) was connected from the implant and terminated approximately

SVP SV2R was installed adjacent to the former UST as shown on Figure 3 and described in Section 3.2. Subsurface soils encountered during the advancement of SVP SV2R generally consisted of clayey silt and silty clay to approximately 5 feet bgs. No odors, staining, or elevated photoionization detector (PID) readings were encountered during advancement of the borings. The boring log and SVP construction details are attached in Appendix A.
